Intel[®] Pentium[®] III Xeon[™] Processor Specification Update

Release Date: May 2000

Order Number: 244460-014

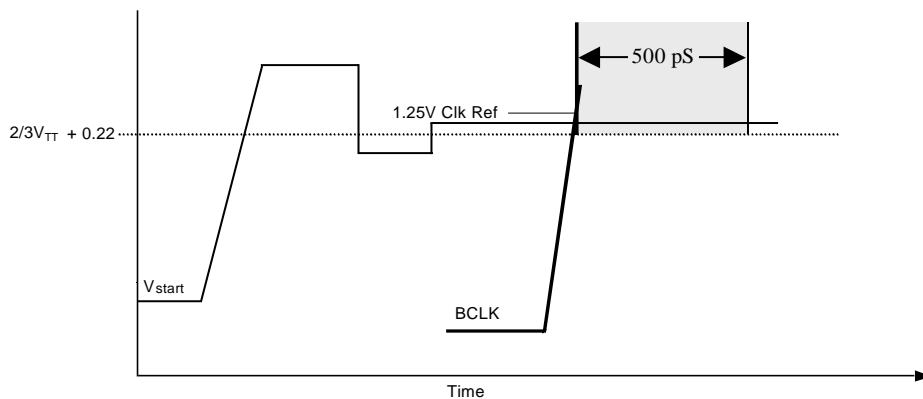
The published AGTL+ AC specification for $V_{IH(MIN)}$ is $(2/3 \cdot V_{TT}) + 0.1$ Volts.

Intel has characterized the new AGTL+ AC specification for $V_{IH(MIN)}$ on the processor's RS0# signal to be: $(2/3 \cdot V_{TT}) + 0.22$ Volts within 500 picoseconds following the rising edge of BCLK crossing the 1.25-Volt threshold. See below.

Implication: The deviation from the published specification results in decreased noise margin on the RS0# processor input. This decreased noise margin has been observed to be particularly detrimental in system environments where the RS0# processor input is being driven by an I/O buffer with a pull-up device (such as a p-channel transistor) that is switched off mid-cycle. Systems that employ I/O buffers that keep the pull-up device on for the entire cycle are significantly less affected by this erratum. The reduction in noise margin may lead to the generation of BINIT# (when enabled) resulting in a system reset, otherwise this condition may lead to a system "hang" condition.

Workaround: If a system design cannot meet the specification deviation, the following areas should be carefully examined to assure that additional margin exists in order to compensate for any deficit observed with respect to the newly characterized $V_{IH(MIN)}$ specification:

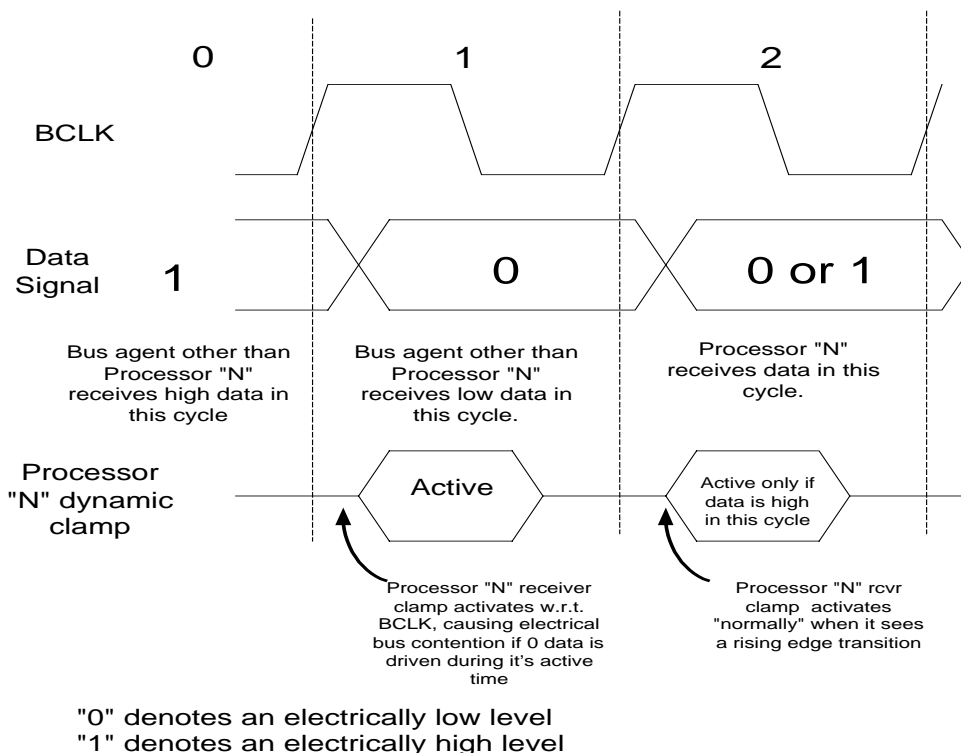
Problem: Falling edge ledge push-out and undershoot may be seen on AGTL+ data and data bus ECC signals. The AGTL+ receiver's dynamic clamp circuit activates (i.e. clamps the signal to an electrically high level) in certain cycles when data is driven to an electrically low level by another agent.

Implication: This erratum only occurs on a processor that does not receive data in that particular cycle. More specifically, this erratum only occurs when a specific processor does not receive data in the current BCLK period, but receives data in the very next period. Therefore, the processor inducing this falling edge noise (on data and data bus ECC signals) will not actually read the data in that cycle. See below for an illustration of this erratum affecting a processor denoted Processor "N". The falling edge ledges and undershoots may affect the signal quality and/or timing at agents that receive data in that cycle. Therefore, the impact of this erratum is highly dependent on system bus design.

Workaround: Evaluate system bus signal quality and timing margin at the valid receiving agent as a result of this falling edge noise. Due to dependence upon system bus design, bus layout may be evaluated to determine the need for improvements in signal quality and timing margin at the valid receiving agent as a result of this receiver-induced falling edge noise.
